THE MITIGATION OF RADIO NOISE FROM EXTERNAL SOURCES

at
RADIO RECEIVING SITES

6TH EDITION

May 2007

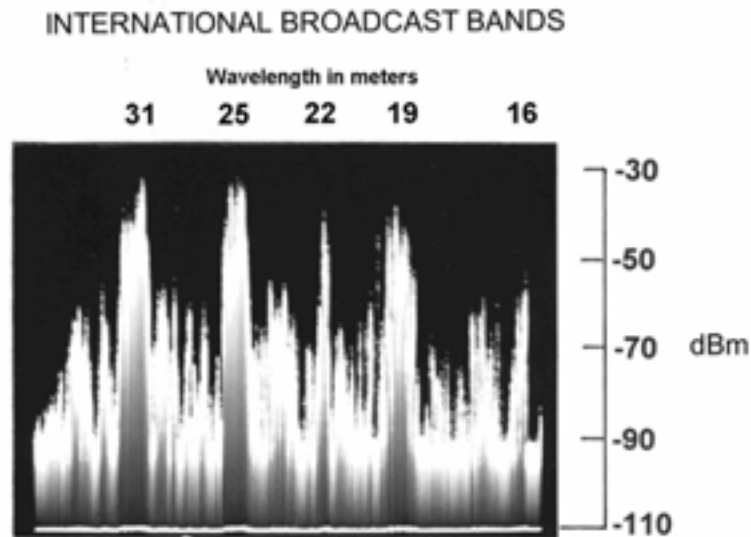
It is useful to first understand the general signal population in the HF band and to relate signals of primary interest to the general signal population. Figure 1 shows an example of the signal levels received in the 8- to 18-MHz portion of the HF band. The signal amplitudes were obtained at 1600 local time, a time of day when the general signal population and signal levels were lowest. Only a few low-level signals were present above and below the frequency range shown due to propagation conditions. The groups of highest-level signals in Figure 1 are signals from transmitters in the International Broadcast Service. They represent signals in the 31-, 25-, 22-, 19-, and 16-meter bands internationally allocated to that service. At nighttime when ionospheric absorption is low, signals in these groups will be 30- to 50-dB higher in amplitude than shown in this figure.

Figure 1 Example of Daytime Signal Levels in the HF Band

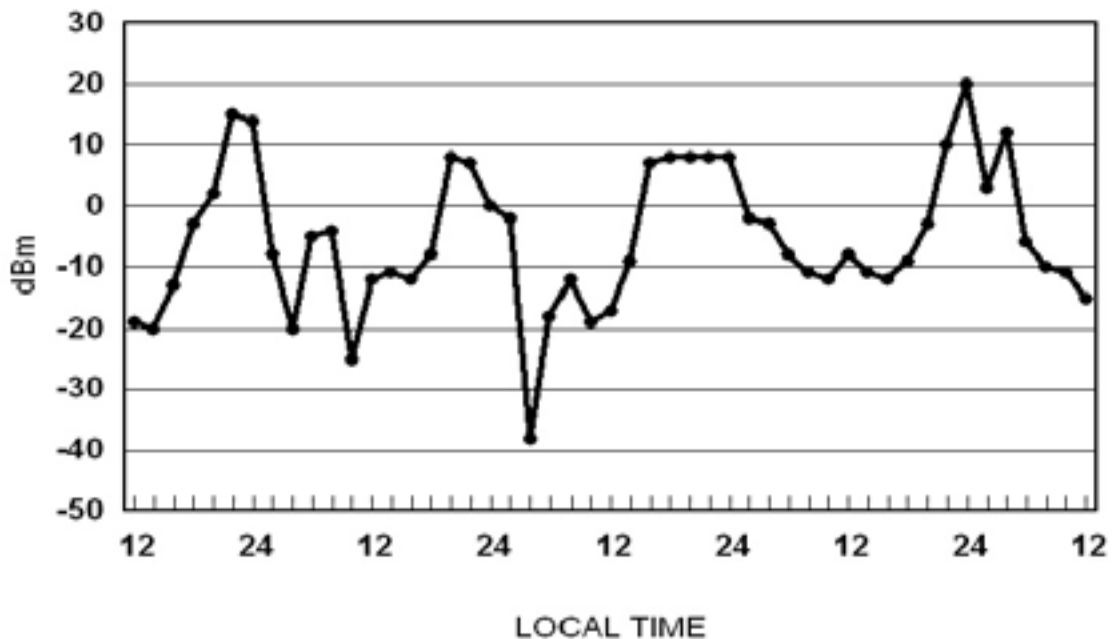
Figure 2 shows an example of the total power delivered from an omidirectional antenna to a 50-Ohm load over a 4-day period. This example was obtained from a European location, but almost identical examples were obtained from all other locations. As shown, daytime power levels are reduced by signal absorption in the propagation path. Nighttime absorption levels are lower, resulting in higher signal levels and higher total power delivered by an antenna.

Figure 2 Total Signal Power Delivered from an Antenna

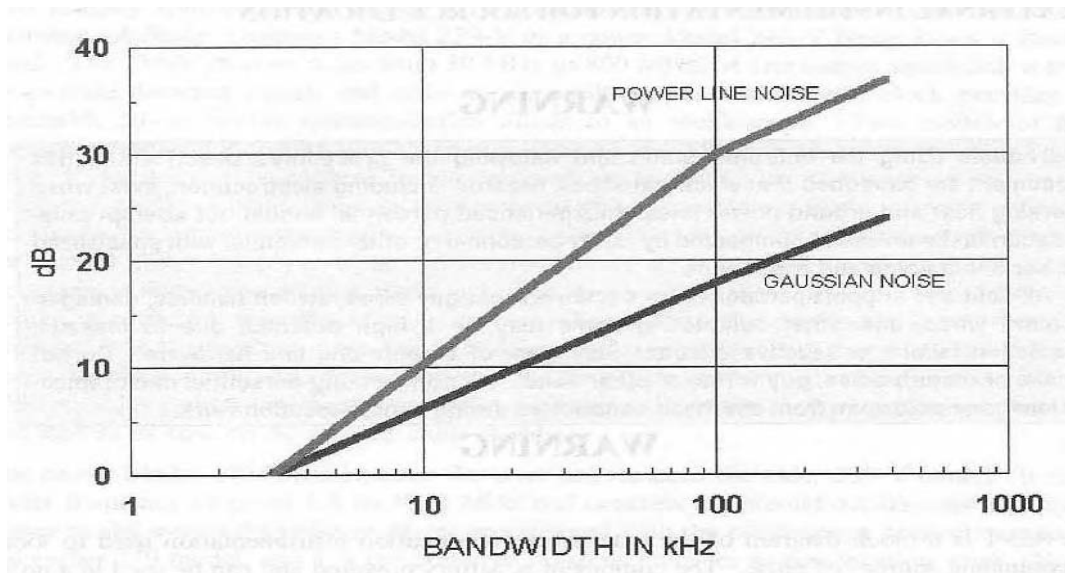
Figure 3 shows how the amplitude of power-line noise changes with instrumentation bandwidth. A similar plot of the amplitude of time-stable Gaussian noise as bandwidth is changed is added to the figure for reference purposes. The amplitude of a discrete-frequency signal does not change with bandwidth.

Figure 3 Bandwidth Scaling Curve for Power-Line Noise

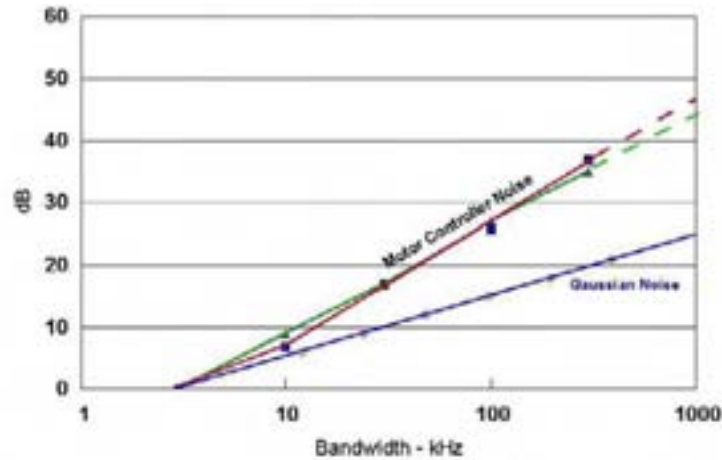
Preliminary data about the amplitude of noise from a few power-conversion devices has been collected as receiver bandwidth was changed. Figure 4 shows plots of data from two types of motor controllers. Again a line representing variation in the amplitude of time-stable Gaussian noise with bandwidth is added to the plot for reference purposes.

Figure 4 Preliminary Bandwidth Scaling Curve for Power-Conversion Noise

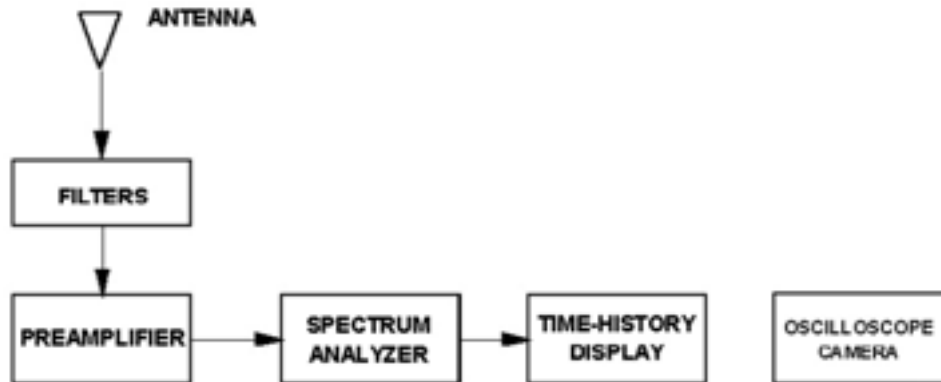
Figure 5 shows a block diagram of the primary site-located instrumentation used to obtain the data presented in this document.

Figure 5 Block Diagram of Site Instrumentation

The antenna should be the one normally used for signal reception at a site. Furthermore, the instrumentation should be connected to the antenna at a location near the receiver. This will allow the instrumentation to examine the same radio-noise conditions which the receiver encounters.

Banks of band-pass filters are used to avoid the high signal strengths found in the International Broadcast Bands. Unfortunately, it is not possible to design conventional discrete-component filters to completely avoid all of the high-level signals in the HF band. The filters were often supplemented with a narrow-band preselector of the kind popular in the early days of radio. Between the filters and a preselector it is possible to obtain sufficient information about low-level signals and noise to achieve the program objectives.

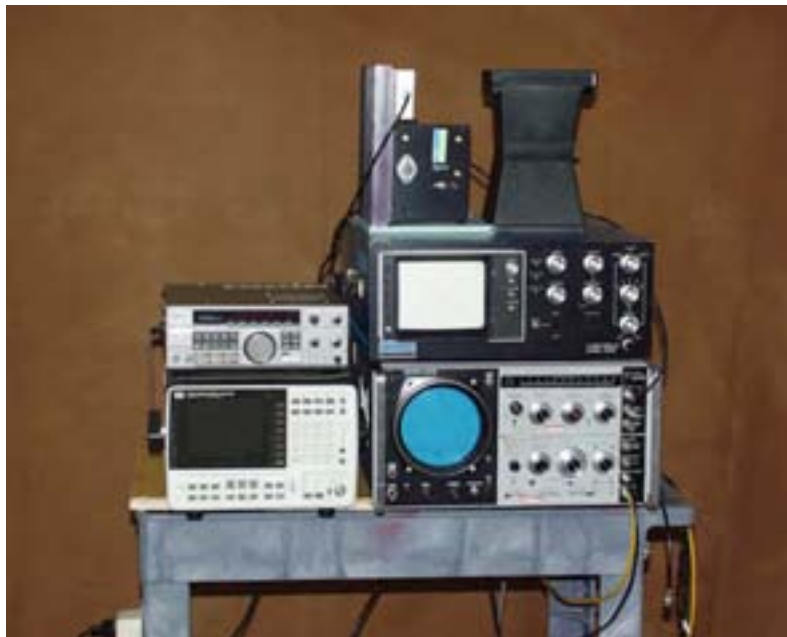
In past years the time-history views were photographed with oscilloscope cameras using Polaroid film. This camera has been replaced with a digital oscilloscope camera, and the resulting digital files are stored on a laptop computer.

Figure 6 Photograph of Typical Site Instrumentation

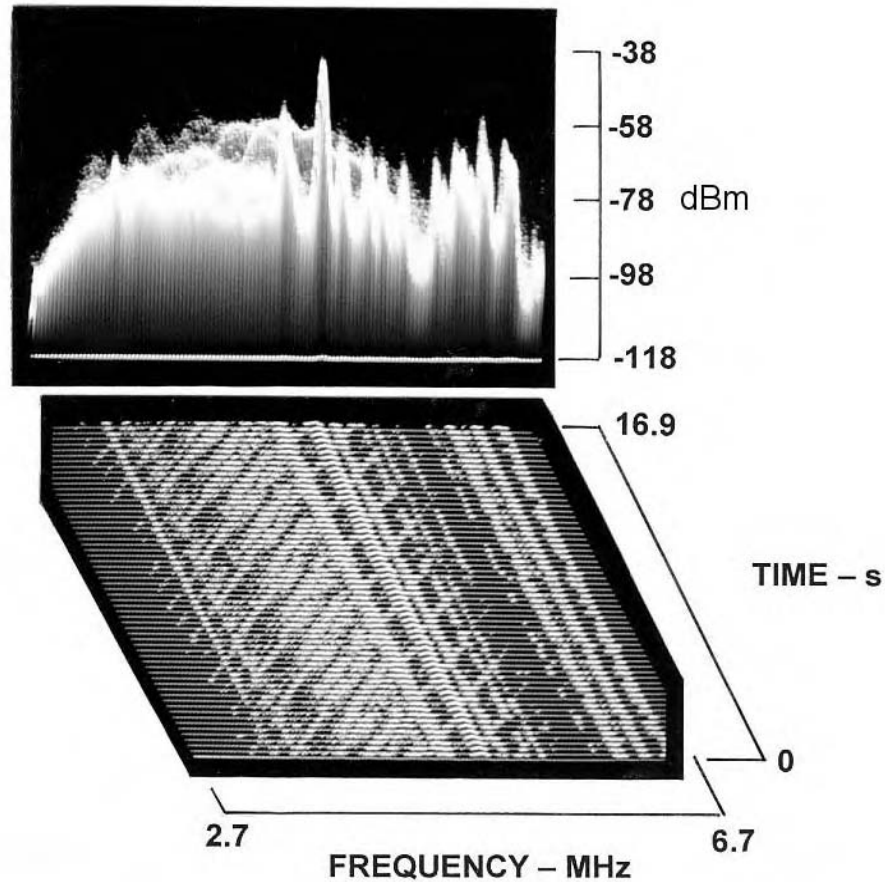
ROT, 000906, 0835, 4.2, 5, 30, 200, LBM 120, PS-3, BPF 2-6, 11, 0, -30

Figure 10 shows an example of noise from multiple sources on a distribution line. The lower view shows that sources are on two phases of a 3-phase distribution line. Both sources were more than 2 km from the site. The upper view shows the spectral shape of each source as well as several discrete-frequency signals.

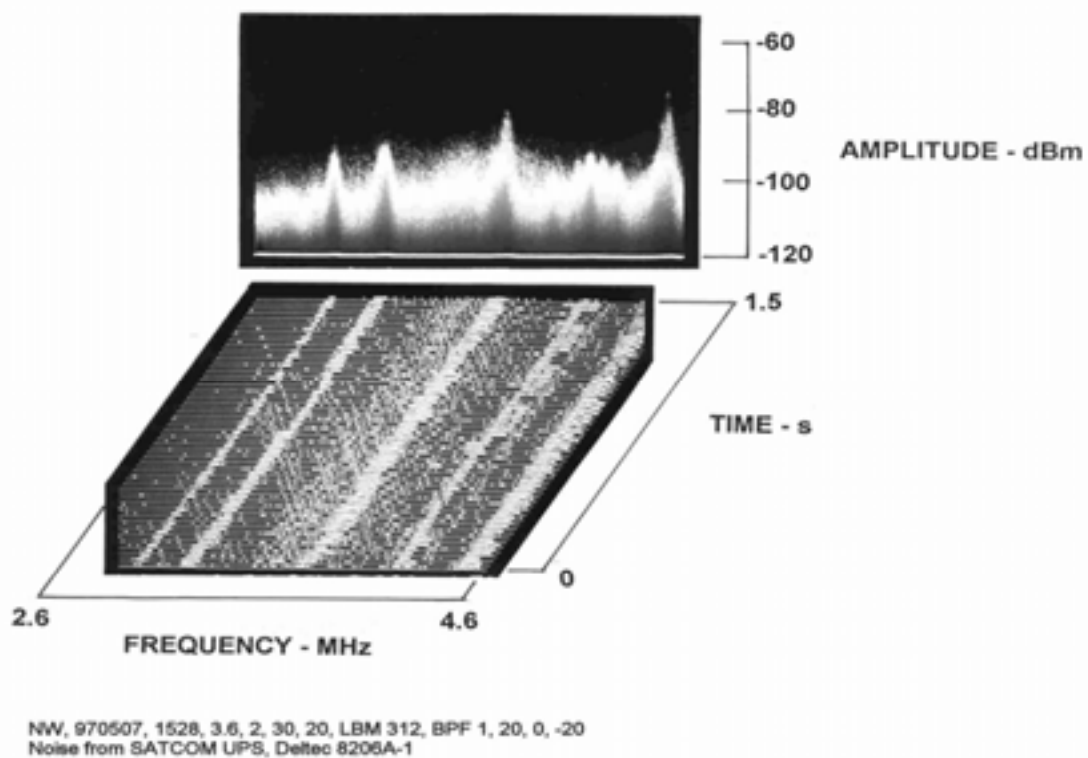
When the satellite terminal was placed into operation, a new radio noise source appeared at the HF site. Figure 26 shows the temporal and spectral properties of the new interference that was traced to the UPS in the satellite terminal. The slanting lines represent impulses from the switching process of the power-conversion devices in the UPS. The UPS noise made it impossible to receive the low-level ambient signals that are also shown in the example.

Figure 26 Interference from a UPS Located 1-km from a Receiving Site

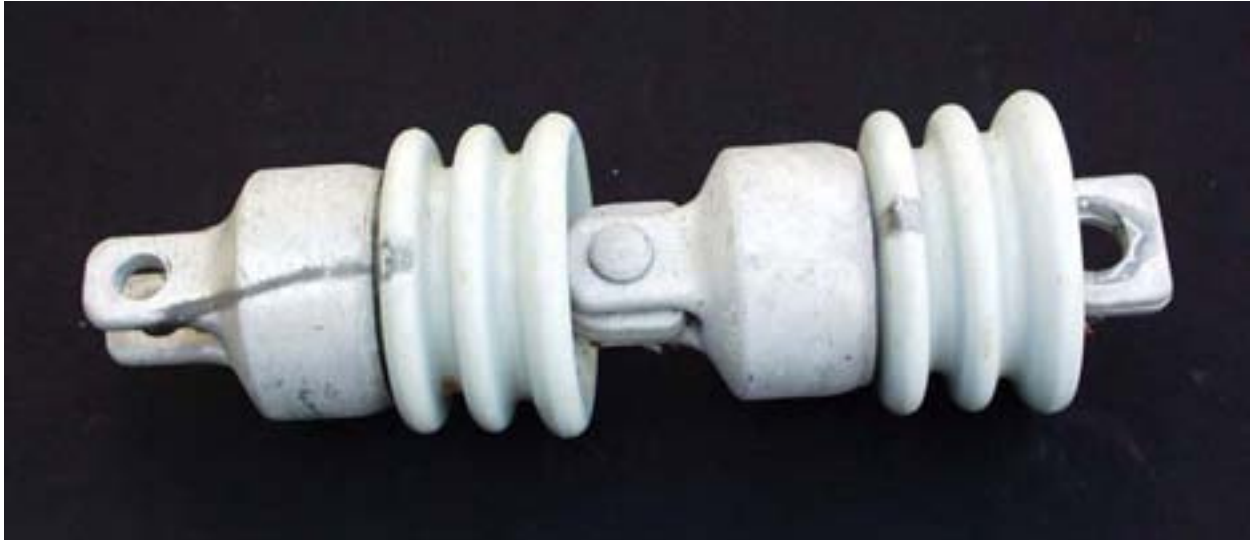
Figure 32 Bell Insulator

The bell insulator is rugged, has a long life (typically 40 years or longer), does not significantly deteriorate with exposure and age, retains its insulation properties with age, normally tolerates flashovers from lightning, and is inexpensive. These desirable properties have made the bell insulator a popular item with many utilities and public works departments. Yet, the bell insulator has gradually been recognized as a major source of radio noise. Because of this, some utilities are now using other types of insulators to replace bells.

The particular bell insulator shown in Figure 32 was removed from service because of lightning damage. A long burn mark is visible on the metal portion of the left section along with a short streak on the left rib of the left porcelain insulator. Another short streak is visible on the first rib of the porcelain at the right end of the bell. In addition, the clevis on the right end of the insulator shows burn damage around its hole. These visible marks on the insulator were caused by a flashover from a direct lightning strike. Apparently the flashover jumped over the center of the insulator.

The burn marks did not result in radio noise, and thus were of no concern to noise-mitigation personnel or to the operation of a nearby radio-receiving site. The decision to replace

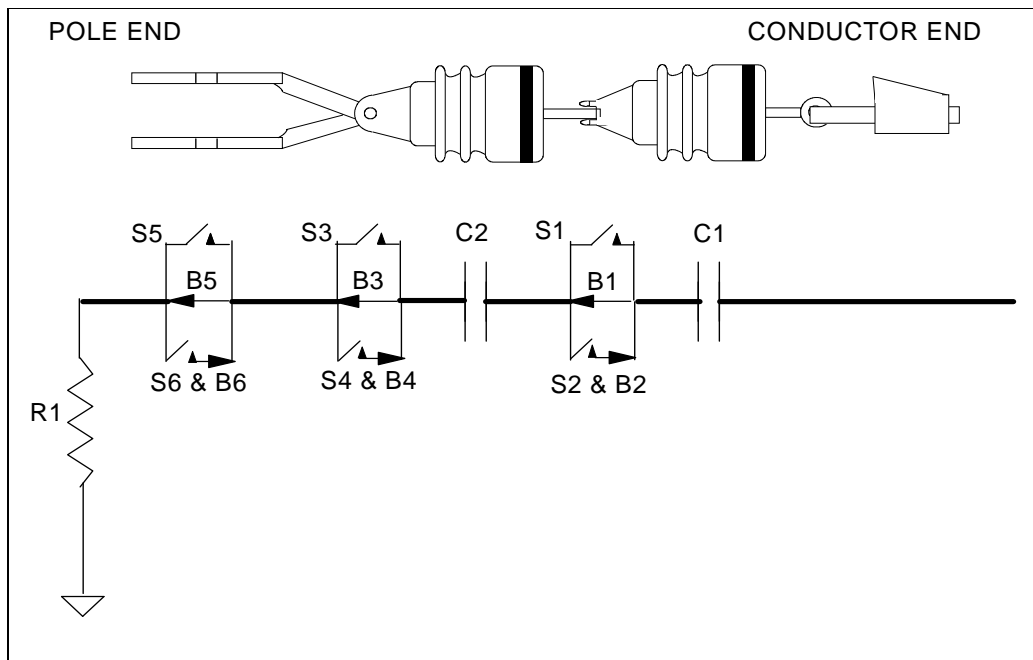
Figure 33 **Circuit Diagram of a Bell Insulator**

The equivalent circuit can be modified to fit a one-, two-, or three-section bell insulator. A two-section bell was chosen for the example since it is the most common configuration found on distribution lines. C1 is the capacitance across the ceramic, or glass, insulation of the section near the hot line. This capacitance is considerably larger for a bell type than other types of insulators because of its internal construction. The metal line-attachment component extends inside the ceramic or glass insulation material and inside the metal component of the opposite side. The two metal components and the high dielectric constant of the insulation material

If S1 is open, then B1, S2, and B2 must be considered. B1 is shown as an arrow pointing left. This represents the insulating oxide layer between the two metal portions of a bell insulator. A charge transfer occurs in one direction across the thin layer of oxide when the oxide breaks down. The arrow indicates the transfer of charge during the positive portion of the line-voltage waveform. A potential of about 800 to 900 volts across the insulating oxide layer will cause it to break down.

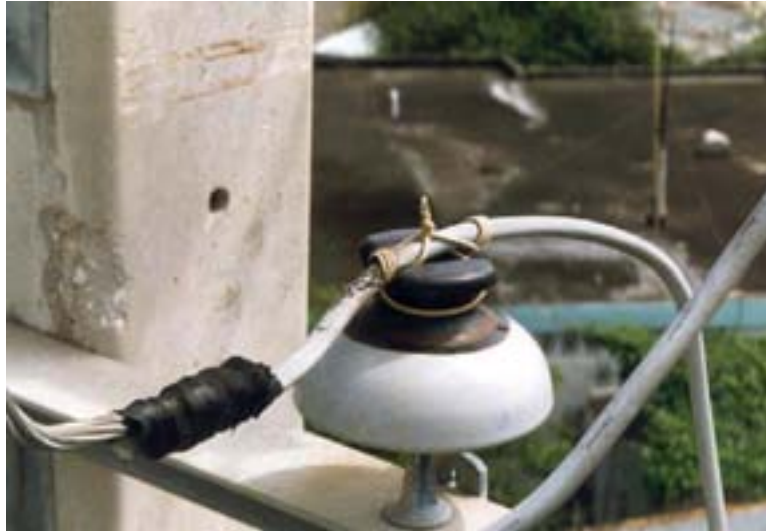
Figure 35 Insulated Tie Wire on an Insulated Conductor

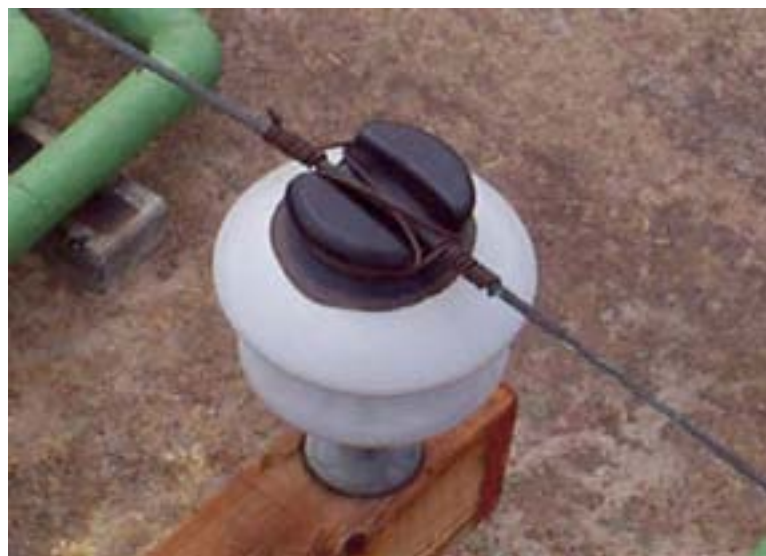
Figure 36 Insulated Tie Wire on a Bare Conductor

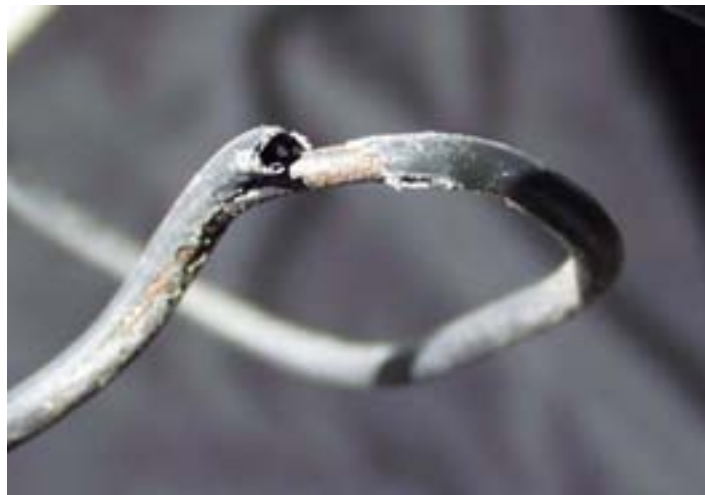
Figure 37 Insulation Failure at a Bend in a Tie Wire

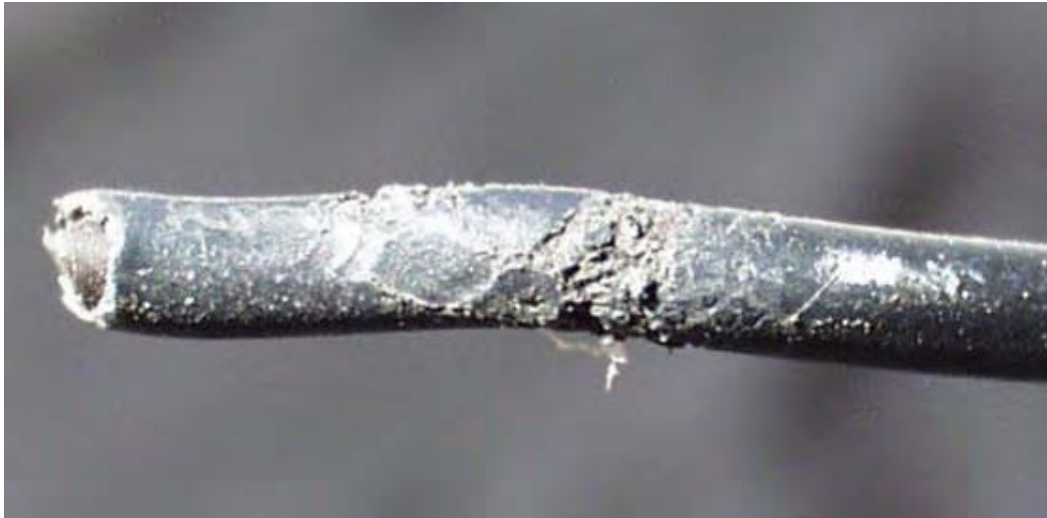
Figure 38 Insulation Failure at the End of a Tie Wire

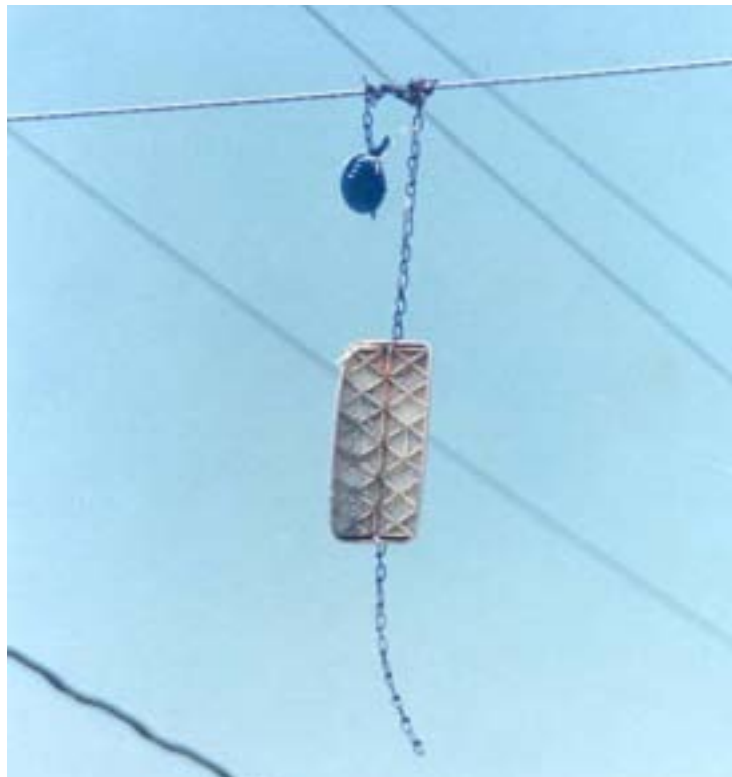
Figure 44 Debris on a Distribution Line Conductor

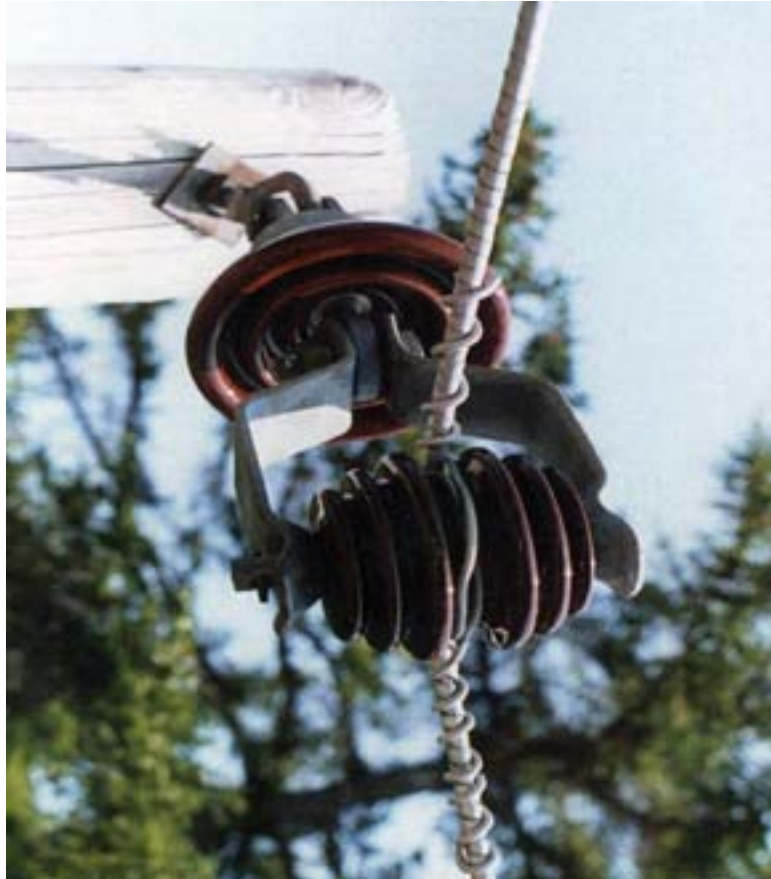
Figure 46 Spool with Insulated Tie Wire and Insulated Conductor

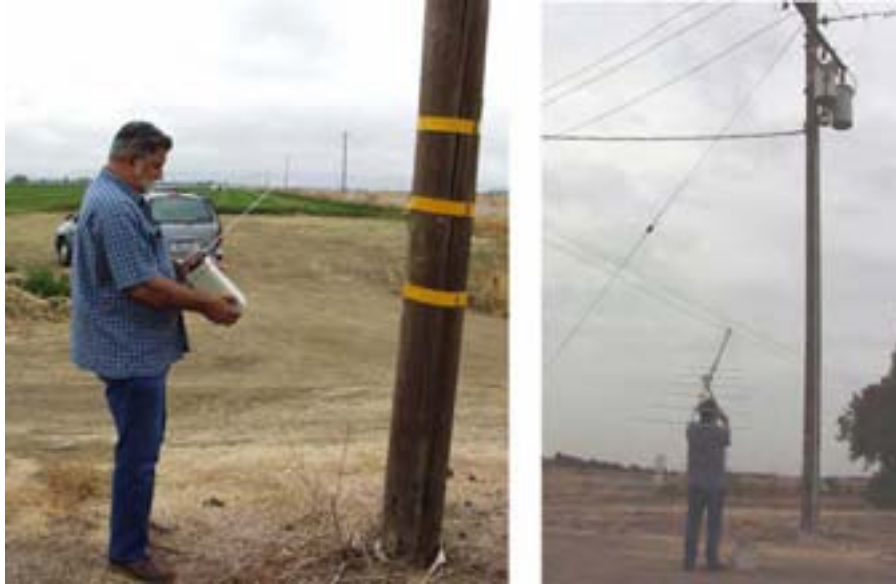
Figure 57 Source-Location Using the Model 240 or 242 Locator

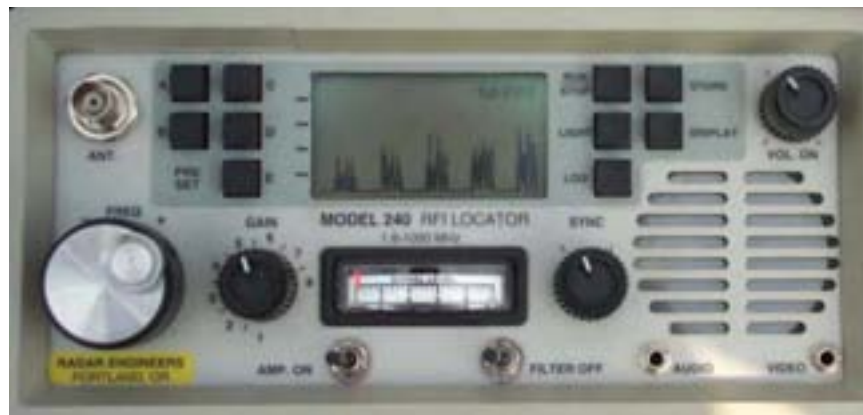
Figure 58 Temporal Display on Model 240 Receiver

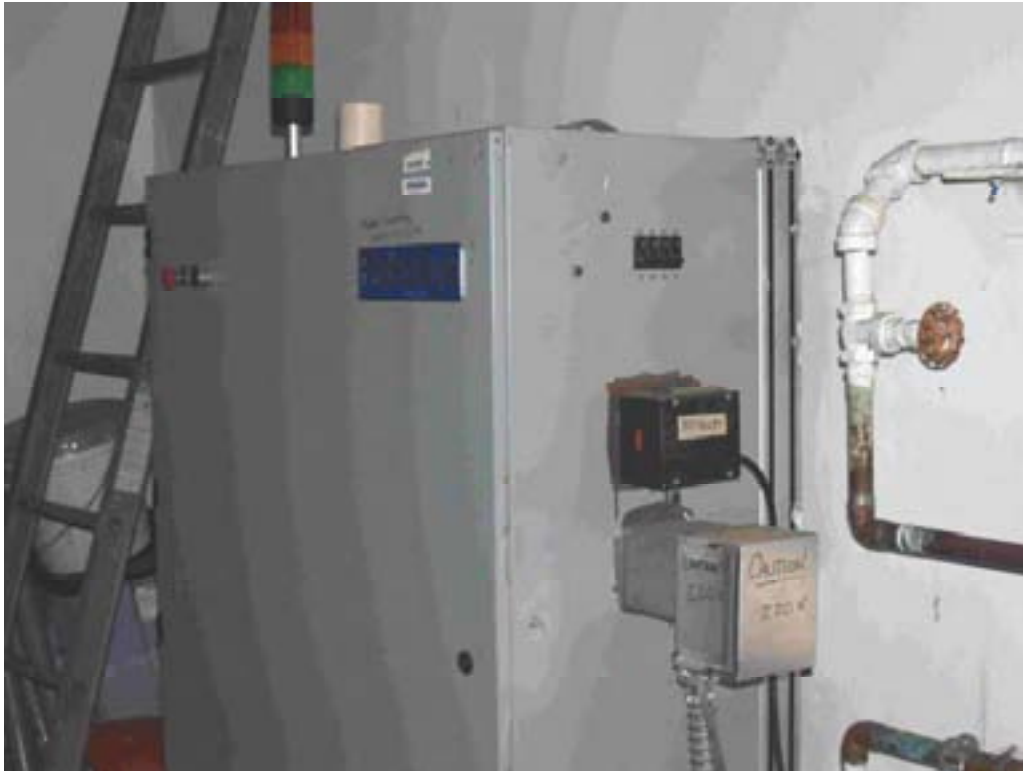
Figure 74 Filter Installation to Suppress Motor-Controller Noise

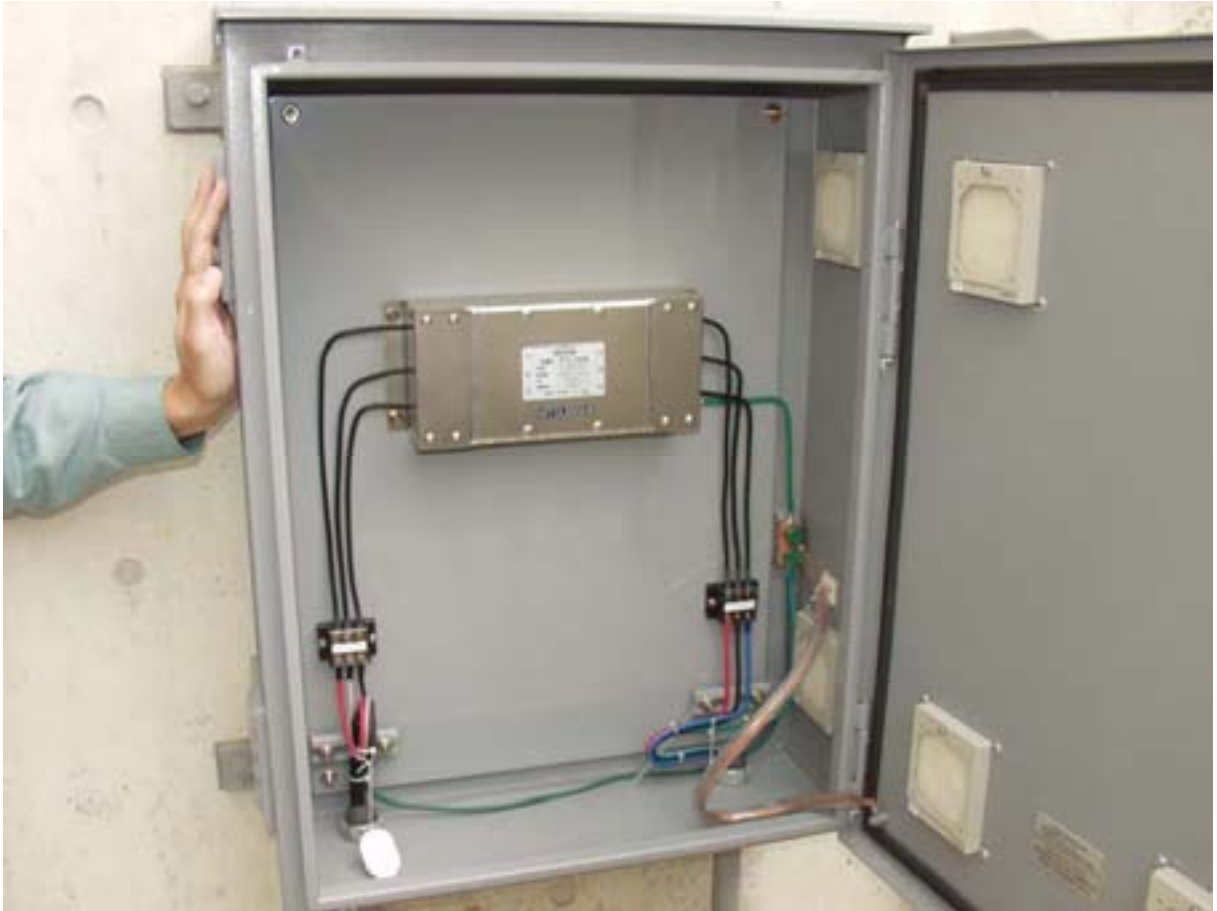
Figure 75 Improper Filter Configuration
